# Manhole Inspection Summary

Manhole # S11OO1024MH

Insp Date: **6/5/07 2:19 PM**

**Location** Address: **2900 WOODLAND AVE**

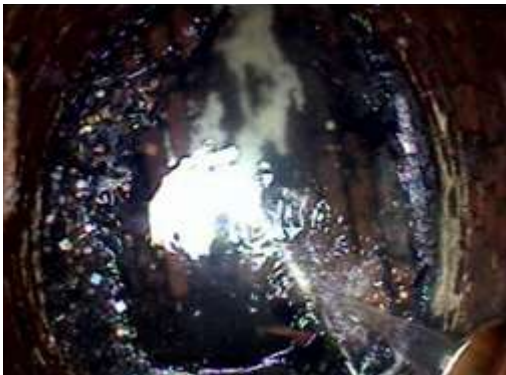
Defect 2

Condition: ☐ Sound ☐ Cracked ☐ Root Intrusion ☐ Deteriorated ☐ Leaks ☒ **Debris**

☒ **Evidence Of Surcharge**

Depth: **2**

EVIDENCE OF SURCHARGE AND  
DEBRIS IN CHANNEL

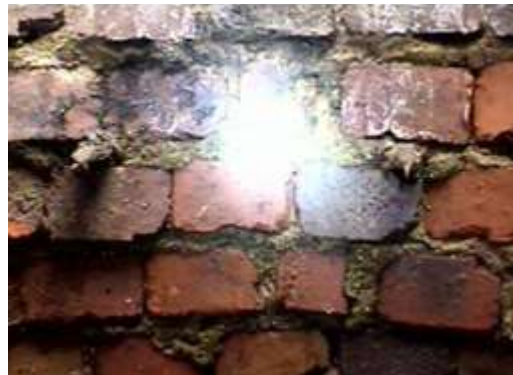
Defect 1

Count: **2**

Missing: **1**

☒ **Corroded**

MISSING/CORRODED RUNG

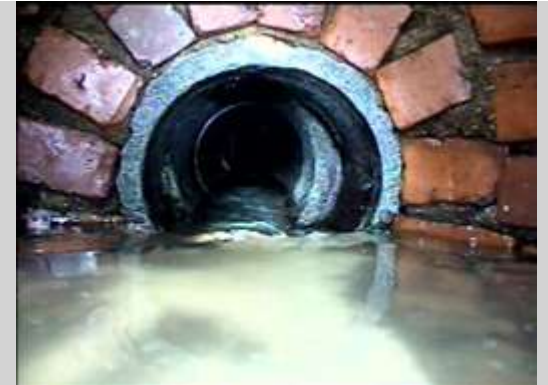
12 O'Clock Outflow

8 in. Circular Gravity Sewer  
Pipe Out @ 12 O'Clock

Pipe Height: (in.) Direct  
Pipe Material: **Clay** ☐ Pipe Lined  
Invert Depth: **6.52** (ft.) Flow Characteristics: **Slow**  
Deposits: ☒ None ☐ Mud ☐ Sludge ☐ Debris ☐ Grease  
Silt Depth: (in.) Deposits Extent:  
Infiltration: **None** Pipe Seal Cond: **Sound**

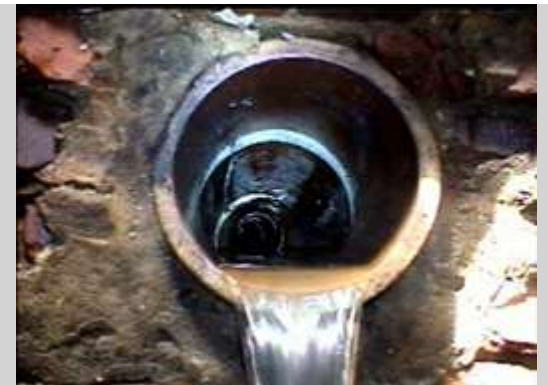
5 O'Clock Inflow

8 in. Circular Gravity Sewer  
Pipe In @ 5 O'Clock

Pipe Height: (in.) Direct  
Pipe Material: **Clay** ☐ Pipe Lined  
Invert Depth: **5.46** (ft.) Flow Characteristics: **Slow**  
Deposits: ☒ None ☐ Mud ☐ Sludge ☐ Debris ☐ Grease  
Silt Depth: (in.) Deposits Extent:  
Infiltration: **None** Pipe Seal Cond: **Sound**
